A technique for repairing a removable partial denture attachment anchor

J Prosthet Dent 2005;94:299-300.

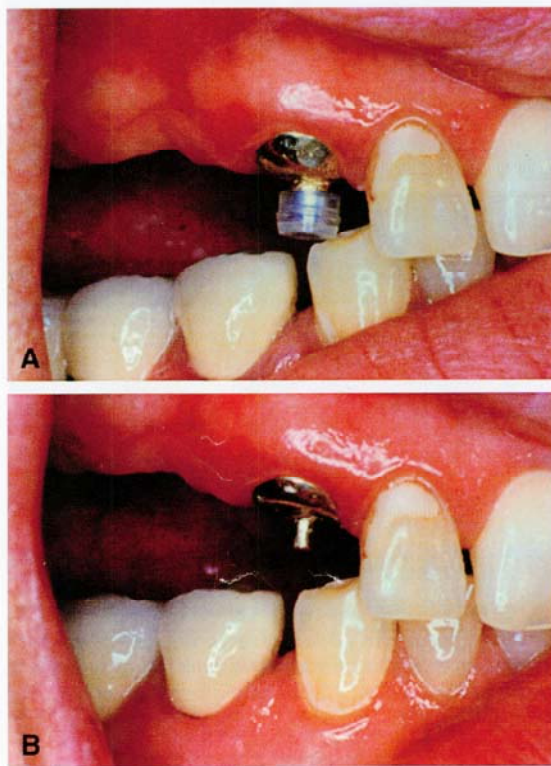
Fig. 1. A, With matrix in place, space was deficient. B, Adjustment of previous matrix and base of dome to gain more space.

position. There was insufficient acrylic resin to accommodate the retentive housing, causing weakness of the denture (Fig. 1, A). Removal of the cast dowel was considered, but because of the length of the dowel, it was not removed for fear of root fracture. The treatment of choice was to replace the existing ball anchor with a repair ball anchor (Rhein'83, Bologna, Italy). With the kit provided by the manufacturer, it was possible to accomplish this chairside.

1. Recontour the existing ball anchor to the shape of a cylinder (approximately 2.5 mm in height and 1 mm in diameter), and move the dome portion apically by using a high-speed handpiece and diamond

rotary cutting instrument (Cat. # 8836KR.314.016; Brasseler USA, Savannah, Ga) with copious water.

2. Evaluate the height of the reshaped metal ball anchor to ensure sufficient space for a new ball anchor, retentive matrix, and thickness of acrylic resin to support the replaced tooth. Polish the dome surface with rubber points (Shofu, San Marcos, Calif) (Fig. 1, B).
3. Under an isolated dry field, cement the Rhein repair ball anchor onto the reshaped ball anchor using autopolymerizing resin cement (Bistite SC; J Morita USA, Inc, Irvine, Calif) (Fig. 2, A).
4. Remove the excessive cement. Transfer the nylon matrix intraorally using a conventional method (Fig. 2, B).⁶
5. Perform occlusal adjustment with articulating paper, followed by polishing the repaired denture in the traditional manner.

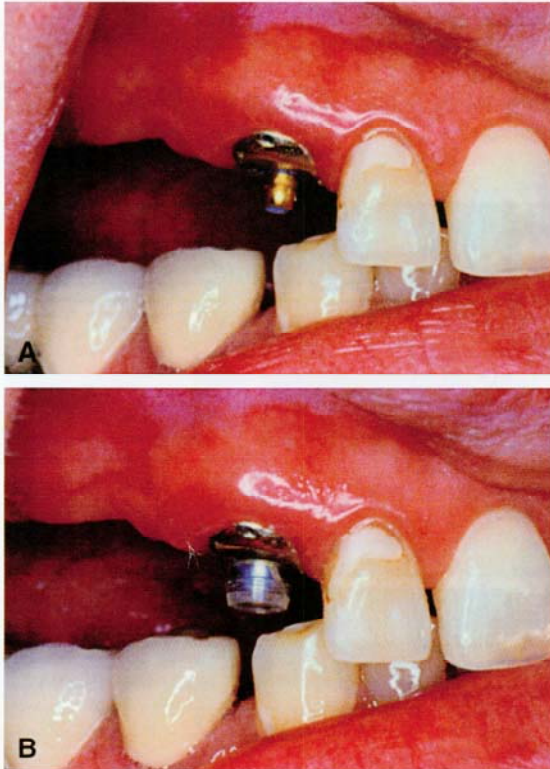
Fig. 2. A, Cementation of ball anchor using resin cement. B, Additional space was gained by this procedure. Matrix was placed and ready to be transferred with autopolymerizing acrylic resin.
